# Manhole Inspection Summary

Manhole # S17EE2023MH

**Location** Address: **1700 KELLY AVE**

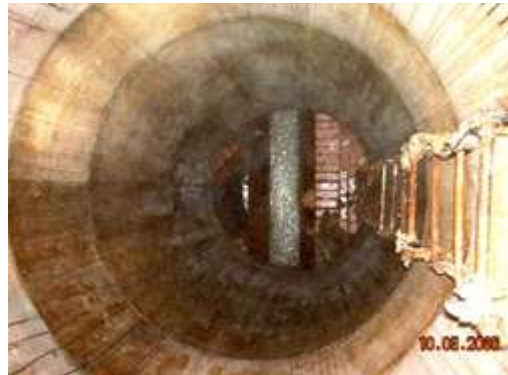
Top View

Corroded steps. Evidence of surcharge - Bench debris.

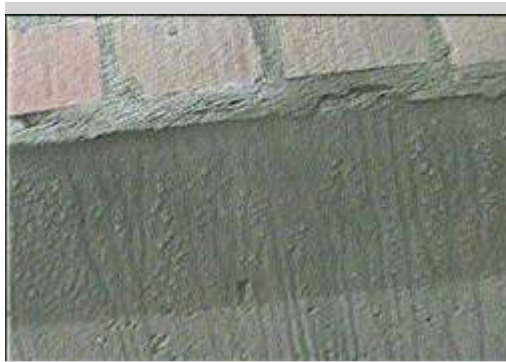
Defect

Adjustment and Corbel infiltration.

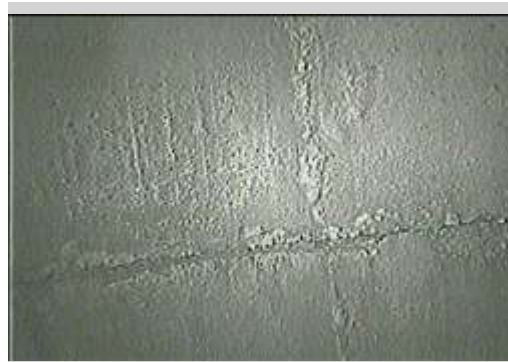
Defect

Barrel infiltration.

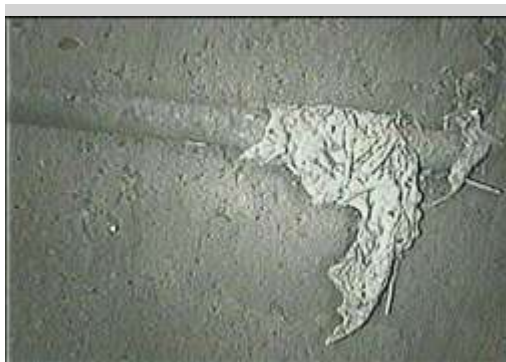
Defect

Evidence of surcharge.

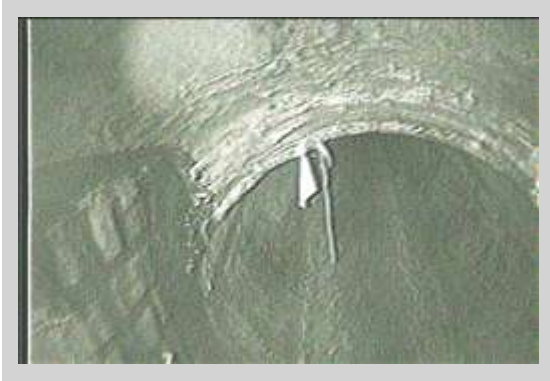
### 24 in. Circular Gravity Sewer Pipe Out @ 12 O'Clock

Infiltration: **Evidence** Pipe Seal Cond: **Unknown**

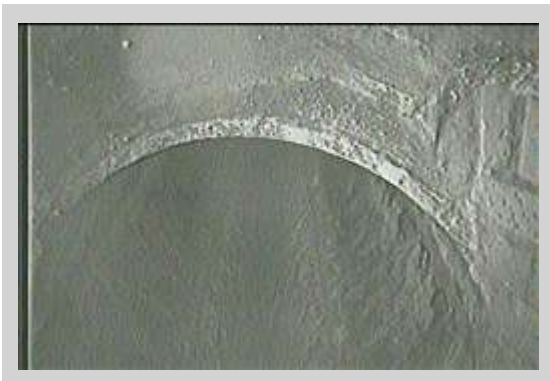
### 21 in. Circular Gravity Sewer Pipe In @ 6 O'Clock

Infiltration: **Evidence** Pipe Seal Cond: **Unknown**
